Polson Water Resource Recovery Facility

Construction Progress Report

(February 2018)

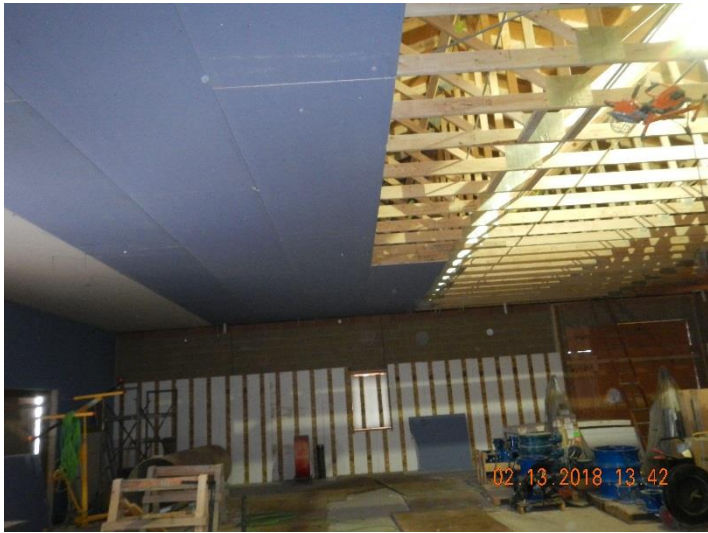
Figure 2 - Headworks Bldg. Interior Wall Insulation

Much of the interior building wall insulation and wall finishes are completed in the headworks building now. Building plumbing, electrical and HVAC work is ongoing. The concrete grit chamber west of the building is in process with the first few concrete pours completed on this complex structure. See Figure 1 and Figure 2.

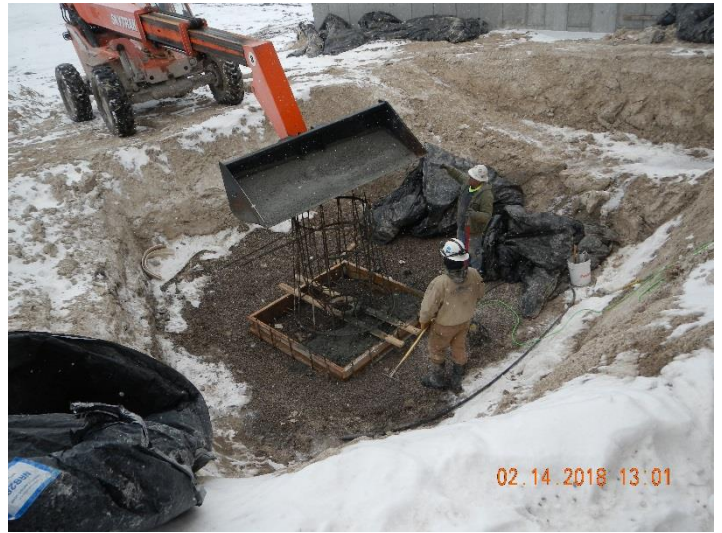
Figure 1 - Grit Chamber Base - Form Work

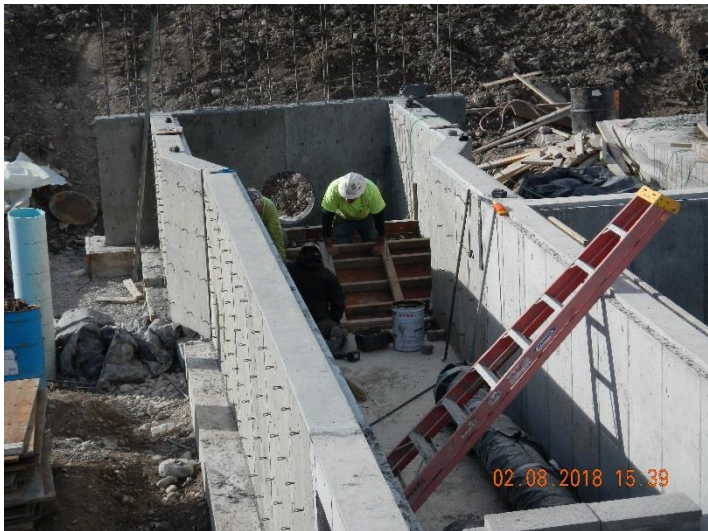
Figure 4 - UV Channels - Exterior Walls

One more concrete pour will complete the concrete post-equalization basin. Further, the exterior concrete channel walls of the UV disinfection channels were completed. Following completion of the tank walls, preparations can be made to leak test this structure as well as move forward with the building wall footings for the UV building attached to the post-equalization tank. See Figure 3 and Figure 4.

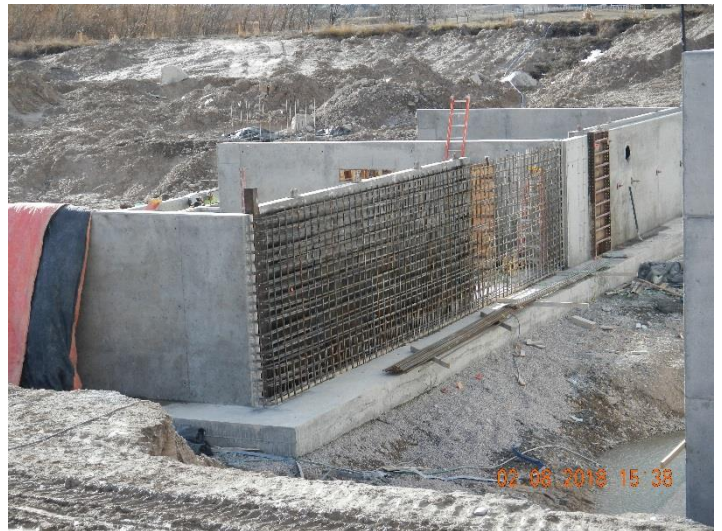
Figure 3 - Post EQ Basin North East Wall - Forming

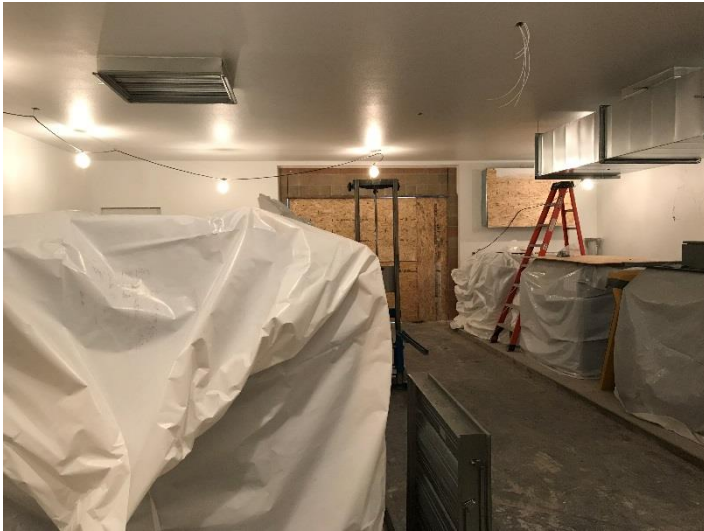
Figure 6 - Control Bldg. Blower Room

The interior walls of the control building are complete and most of the ceiling is installed in the control building. Building electrical, heating and ventilation work is well along. The process

blowers and the digester blowers are set in the blower room and the aeration piping leaving this room is nearly complete. The process piping is completed short of minor instrumentation taps, painting and final adjustments and pipe supports. Air handling units are set in the basement. See Figure 5 and Figure 6.

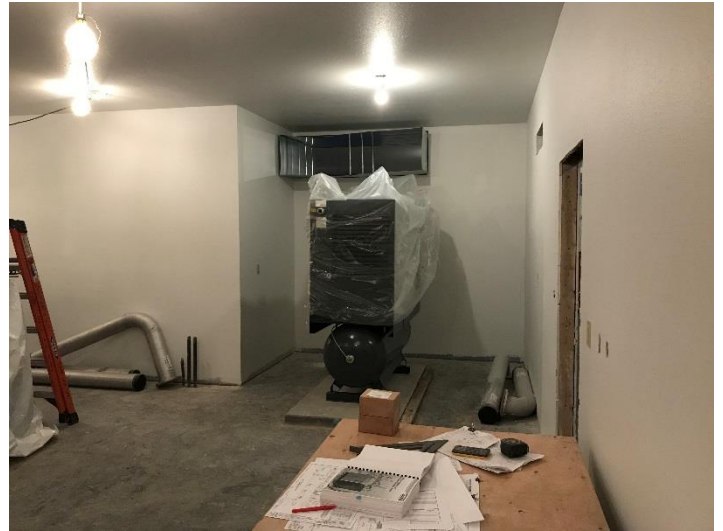
Figure 5 - Cntrl Bldg.; Compressor For Digester Mixing System

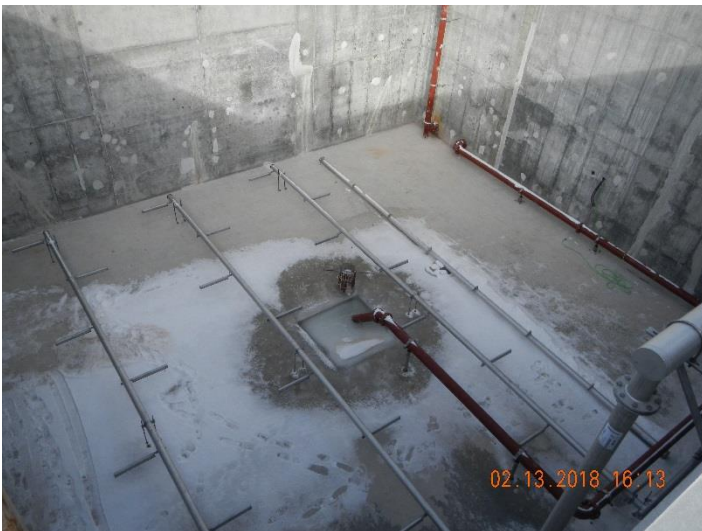
Figure 7 - Digester 1; Aeration Piping & Sludge Piping

Work continued inside the digester #1 on the sludge piping, the aeration air piping and equipment and the compressed air mixing system. This work is now progressing in digester #2. See Figure 7 and Figure 8.

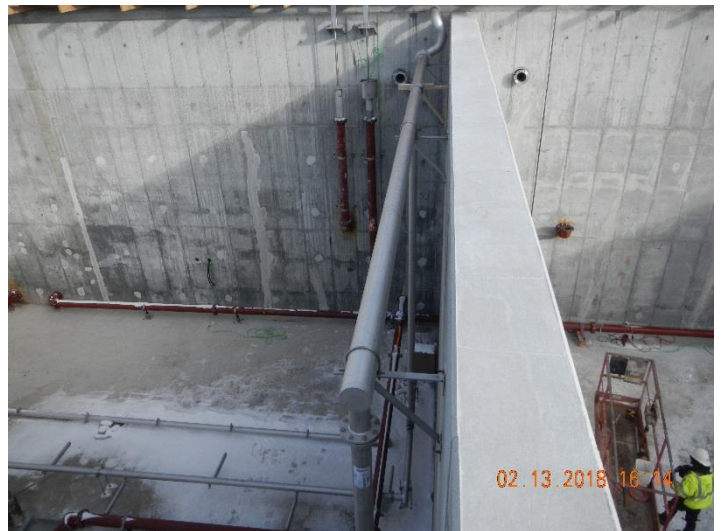
Figure 8- Digester 1; Aeration Piping
