Polson Water Resource Recovery Facility
	Construction Progress Report
	(December 2017)
то:	Mark Shrives, City Manager 106 First Street East City of Polson, MT 59860
CC:	Polson City Council Ashley Walker, W/S Superintendent
FROM:	Kevin Johnson, P.E. Project Manager – DOWL
DATE:	December 28, 2017

This construction progress report includes work for the month of December 2017.

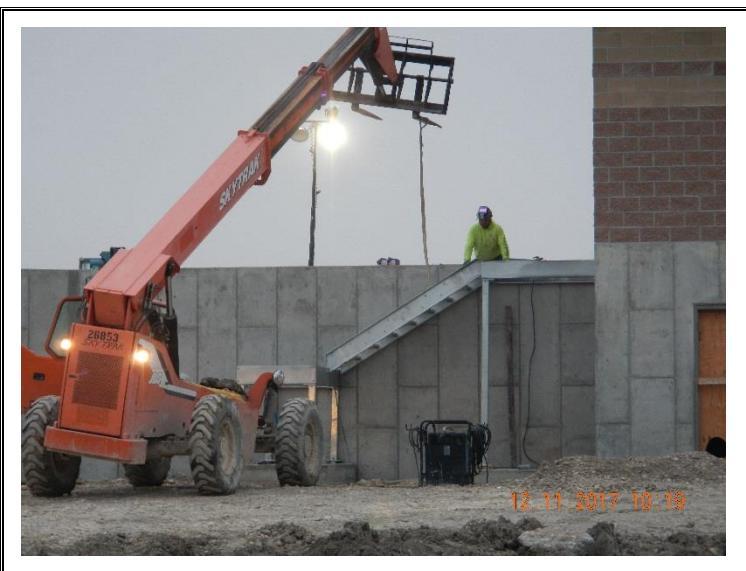
The roof structure for this building was completed this month and some various plumbing and electrical work was completed. The exterior stairway was installed and the access road to the lower level was finished along with placement of a drainage culvert across this access road. The excavation for the grit chamber was completed and a temporary enclosure was constructed for heating of the area when this concrete work for the grit chamber resumes. See Figure 1.

Figure 1 - Headworks Bldg. Ext. Stairs

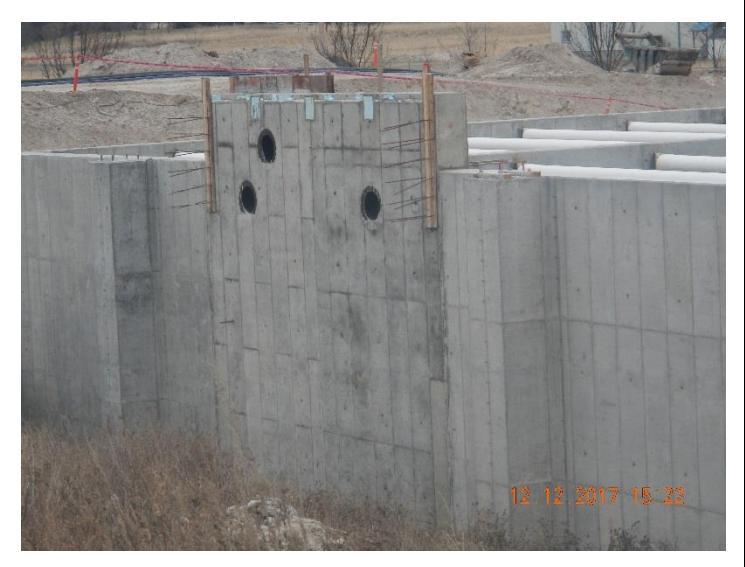
The final three (3) concrete pours for the biological process (SBR) tanks were completed. The structural steel braces across the tanks are complete and the steel walkway along the top of the tank divider wall was started. The SBR tanks are now ready for the leak testing before any backfilling around these tanks can proceed. However, the leak testing has proven to be impractical and not advisable during the freezing temperatures. The structure is too large to effectively heat to keep the exterior side of the concrete walls above freezing to allow observation and possible repair of any seeps. Thus, this work is on hold until weather conditions are favorable for this quality control to proceed. The delay in leak testing causes delay in backfilling around the tanks and completion of the pipework within the backfill. Further, the concrete inlet and outlet vaults and associated process piping within the vaults cannot proceed until leak testing and backfilling are completed. See Figures 2 and 3.

Figure 2 - North Wall of SBR - Complete

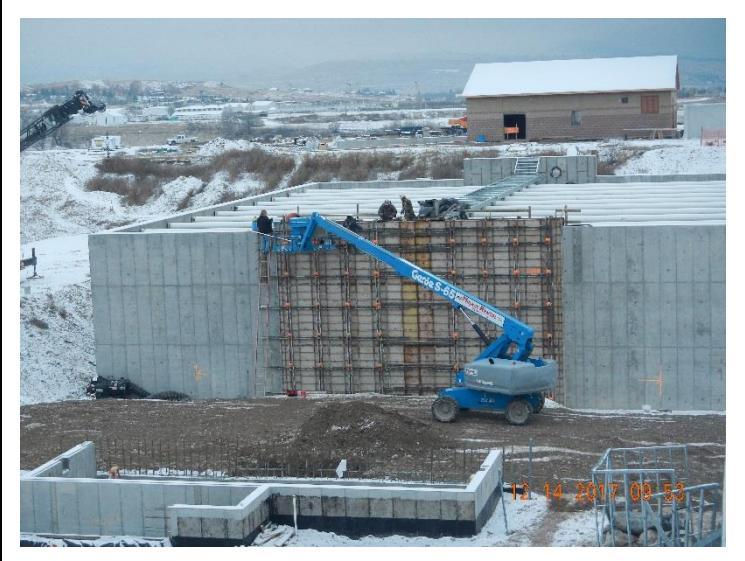
Figure 3 - South Wall of SBR- Last Pour

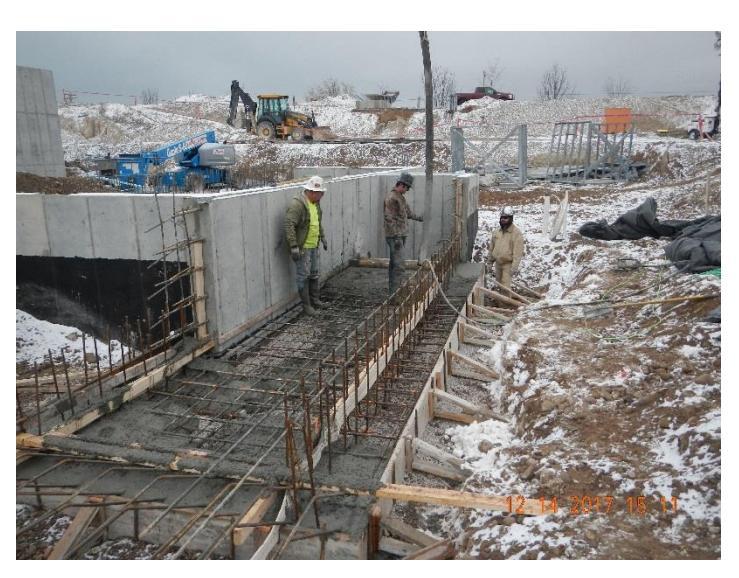
Several additional concrete pours were completed for the lower pipe gallery and the ultraviolet light flow channels. Some various electrical conduit and building plumbing (floor drain) work and backfill work was completed for this structure. Work on forming of the post equalization tank floor is next but is currently on hold for better weather conditions to prevail. See Figure 4.

Figure 4 - UV System - Flow Channel Floor

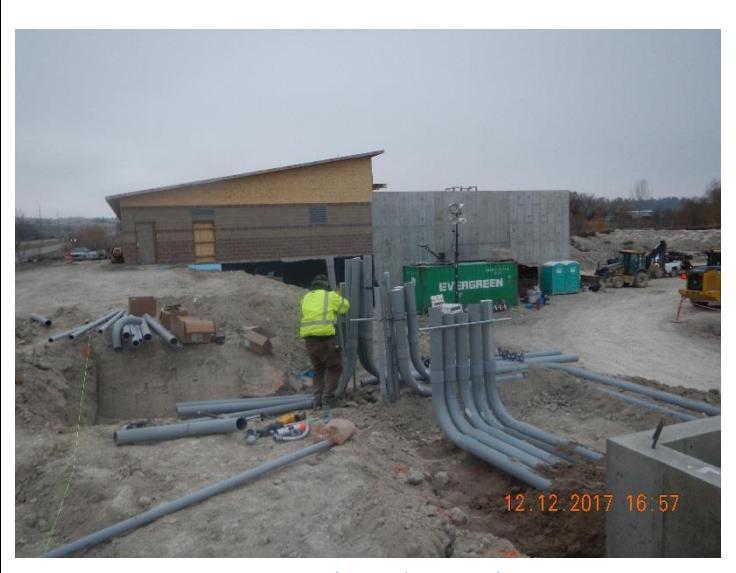
Coordination with Mission Valley Power for the new electrical service resulted in some changes to how the power lines will get to the new facility. The location of a new power pole proposed by Mission Valley Power would have immediate conflicts with other buried utilities and result in trenching through the borrow ditch and tree roots on the project property. The approach was revised to include an underground crossing of Kerr Dam Road and ultimate removal of the power poles on the west side of Kerr Dam Road. There will be no aerial crossing and the necessary trenching on site was greatly simplified. The cost from Mission Valley Power was reduced but the underground drilling of conduits under Kerr Dam Road is required and will be completed by a subcontractor for Swank Enterprises. The net increase in cost of this improved approach will be approximately \$7,000. Some of the electrical site work is shown in Figure 5.

Figure 5 - Electrical Site Work

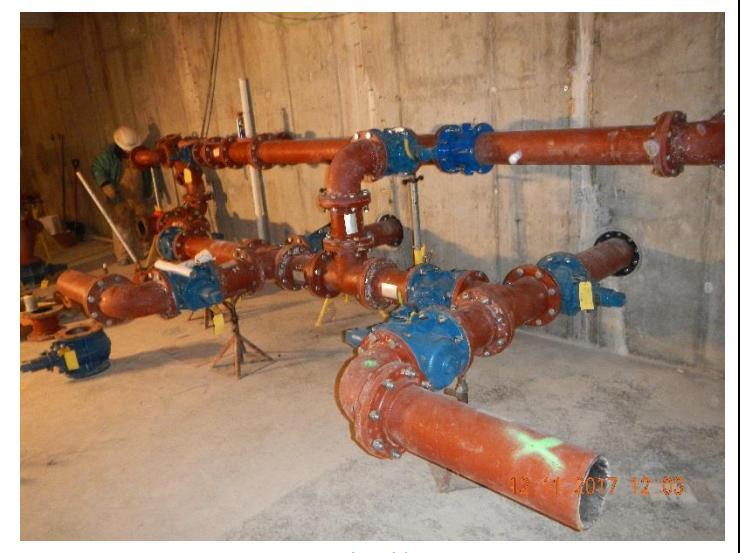
Work within this building in December included framing of all the interior walls of the upper floor for the office, lab, mechanical, bathroom, blower room and chemical feed rooms. Drywall installation on the ceiling is nearly completed. Heating, ventilation and electrical work for duct work penetrations and various building wiring provisions proceeded throughout the building. The process mechanical piping in the basement is nearly complete. See Figures 6 and 7.

Figure 6 - Control Building Process Pipe

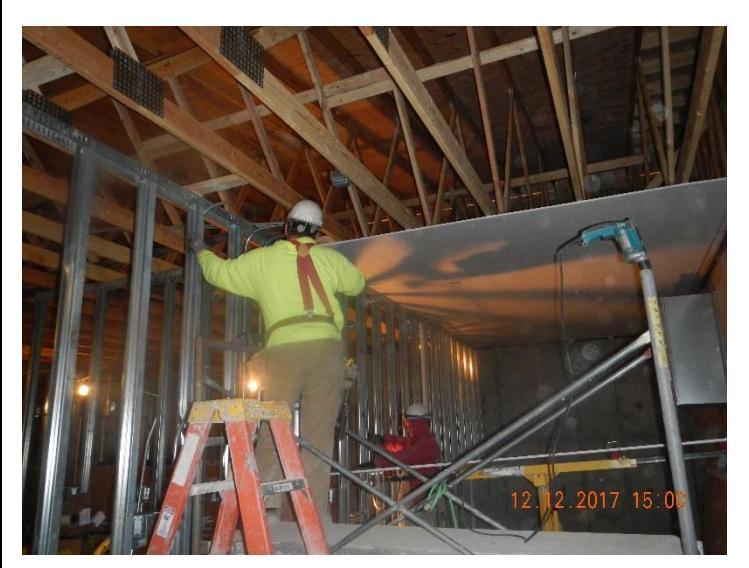
Figure 7 - Control Building - Upper Floor Framing and Drywall

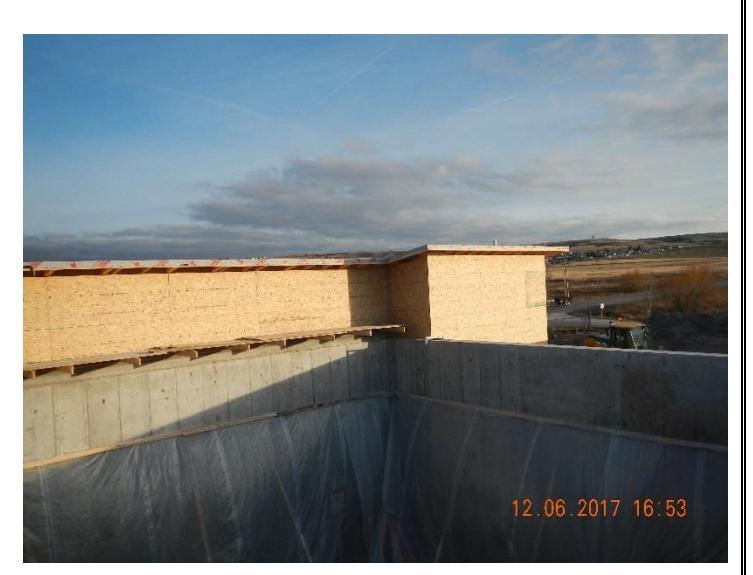
Mitigation work for the remaining seeps in the digester tanks proceeded through December with work on the inside of the tanks. The tanks were refilled to check the status of the remaining seeps. While there appears to be significant improvement there are still a few areas where seeping is still present. Because of the freezing temperatures the tanks were again drained and corrective work will have to resume when weather conditions are more favorable. See Figure 8.

Figure 8 - Inside Digesters - Seep Repair, Heating Provisions
