# Polson Water Resource Recovery Facility

## Construction Progress Report

For Month of July 2017

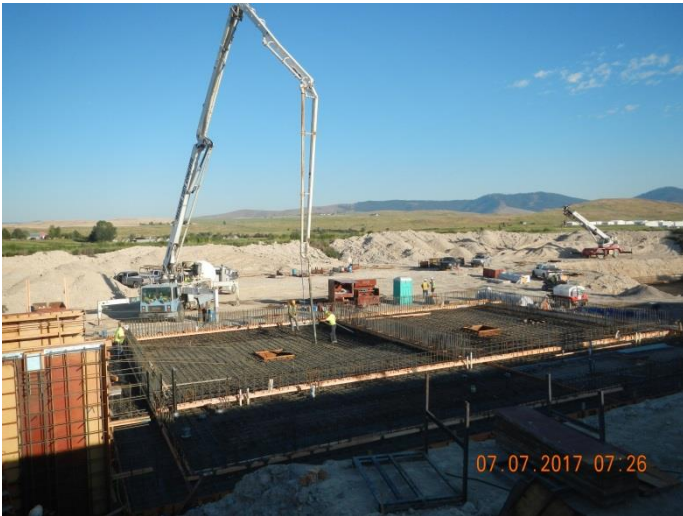
Figure 1 – Digester Floors Concrete Placement

Digesters/Control Building: The entire concrete foundation slab (i.e. tank floors) for the two aerobic digesters and the control building basement floor was completed this period. Along with these floor sections a retaining wall and foundation wall on the south end of the control building was completed. The first digester wall section was poured July 26. A total of five (5) pours will be required for the digester walls. The digester walls include approximately 350 cubic yards of concrete.

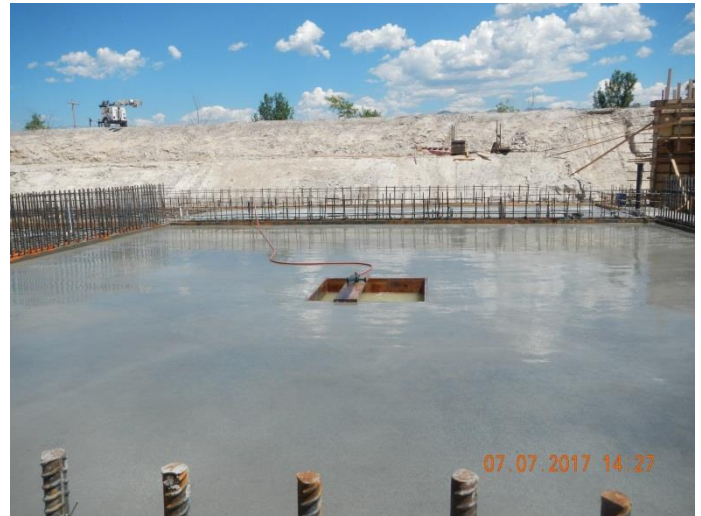
Figure 2 – Completed Digester Floor; Sprinkler Keeping Slab Wet

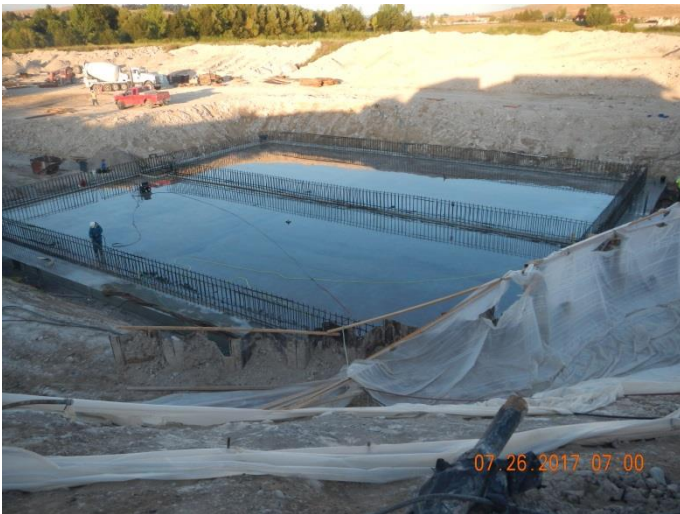
Figure 3 – SBR Basin – Foundation Completed, Covered with Water for Curing

SBR Tanks: The entire foundation slab (i.e. tank floor) was completed this period. The next step for the SBR tanks will be placement of the wall forms and rebar curtains for pouring of the concrete walls. The walls for the SBR will include approximately 850 cubic yards of concrete.

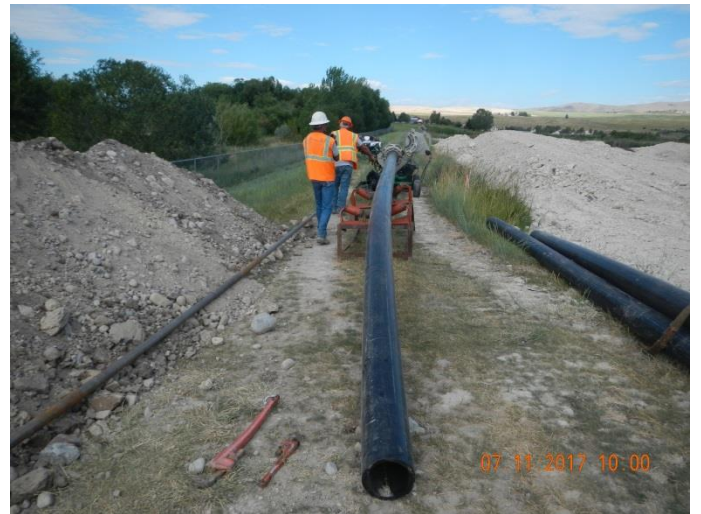
Figure 4 – Fusion Welding HDPE for Pulling Under Kerr Dam Road; Potable Water Main

Potable Water Main: A new potable water main was bored under Kerr Dam Road to west side for supply of potable water to hydrants and the treatment facility. Final connections and testing of this main will commence over the next couple weeks. This water supply is needed for filling of the digesters for the required leak testing of these tanks.
